TRONOX KZN SANDS

FAIRBREEZE MINE
EXTERNAL AUDIT OF EMPr and EAs
January 2023 – December 2023

Audit Findings and Summary Report

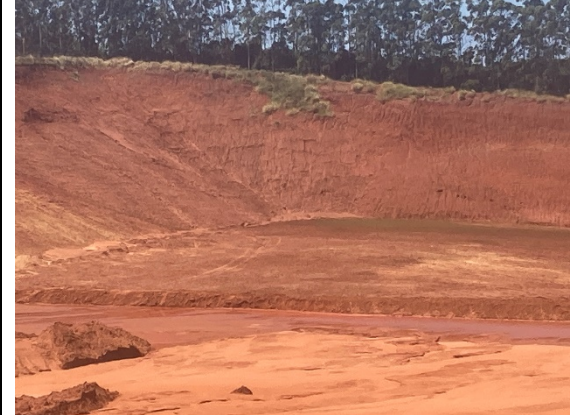
<p>All mining areas are access controlled and suitable signage has been erected on the mine.</p>	<p>B orebody - mining operations underway.</p>

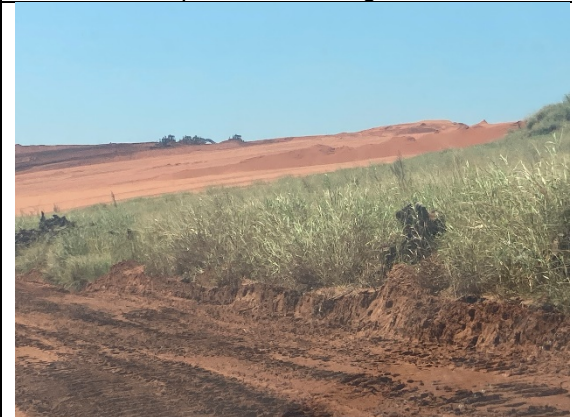
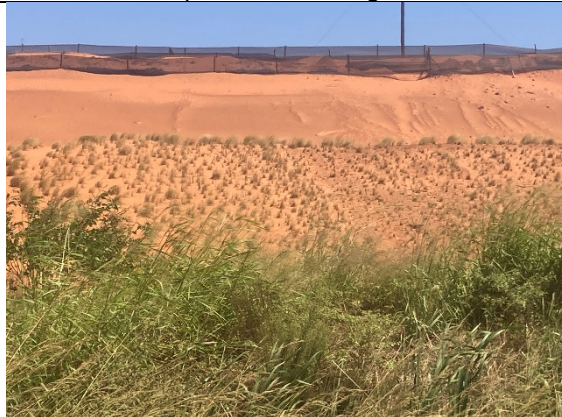
<p>Backfilling of C-extension orebody which has now in the process of being rehabilitated.</p>	<p>Backfilling of C-extension orebody which has now in the process of being rehabilitated.</p>
