**TRONOX KZN SANDS**

**HILLENDALE MINE**

**EXTERNAL AUDIT OF EMPR**

**Audit Findings and Summary Report**

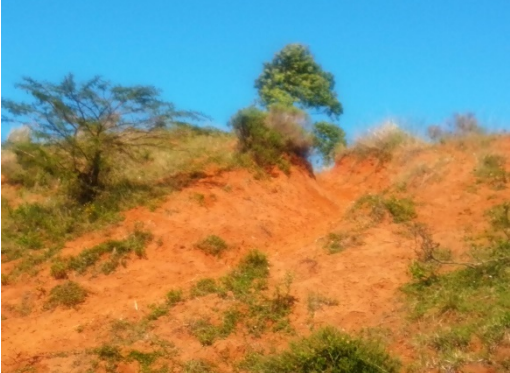
<p>Footpaths of cattle and goats are resulting in some erosion on steep banks on site.</p>	<p>Drainage canal adjacent to a mined area which is suitably grassed and maintained.</p>

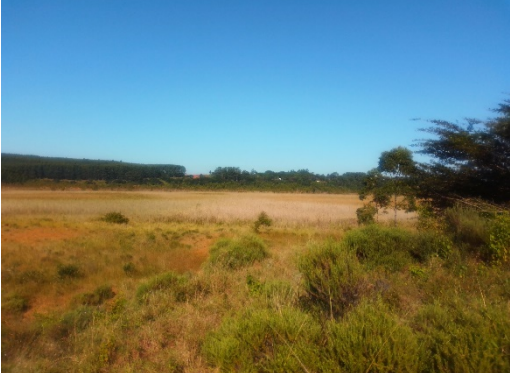
<p>The residue storage facility which is drying out and trees and natural vegetation is becoming well established.</p>	<p>Banks around the RSF are well maintained and no signs of erosion are visible on the embankments.</p>
